construction
engineering
research
laboratory

TECHNICAL REPORT M-258
April 1979

FRACTURE CHARACTERISTICS OF
STRUCTURAL STEELS: REFERENCE MANUAL

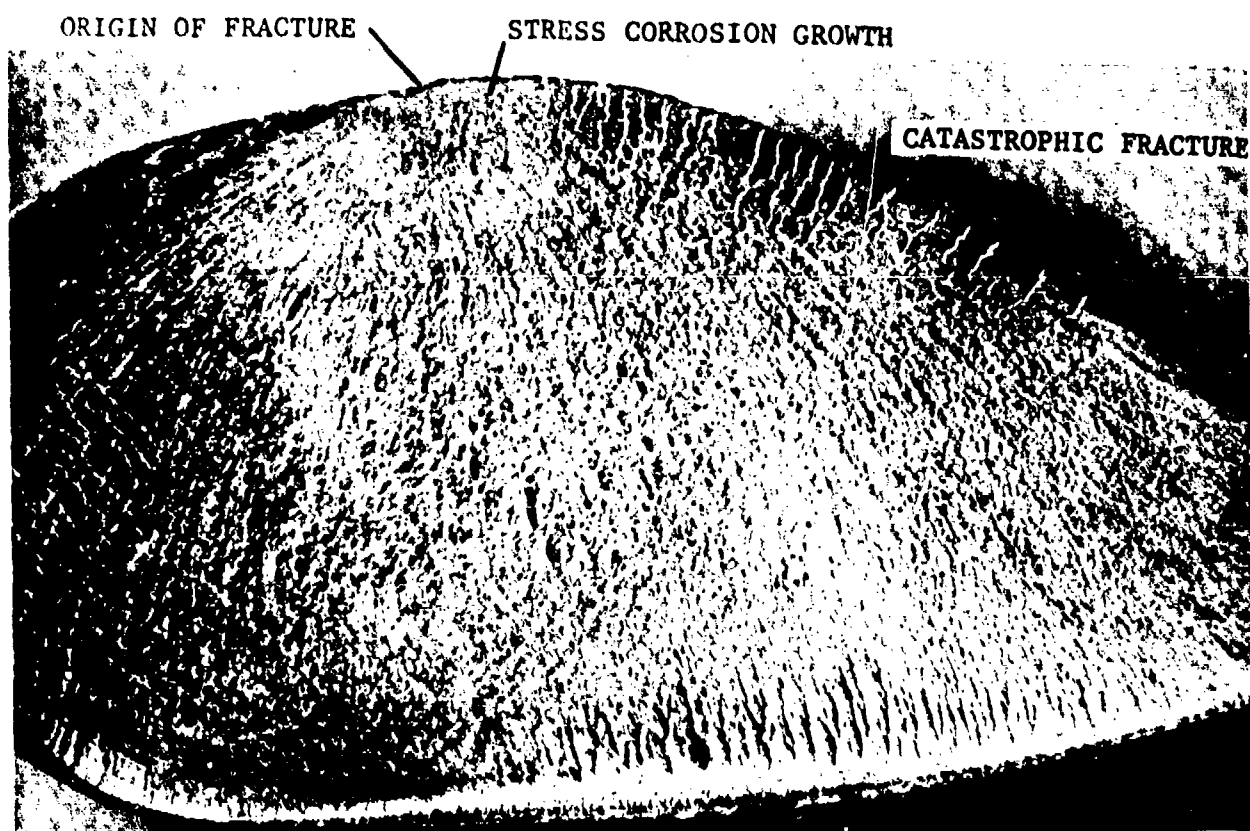
Figure A13. Fracture surface of spring No. 21 as photographed under fluorescent light, with wet magnetic particles sprayed on the surface to enhance ridges.

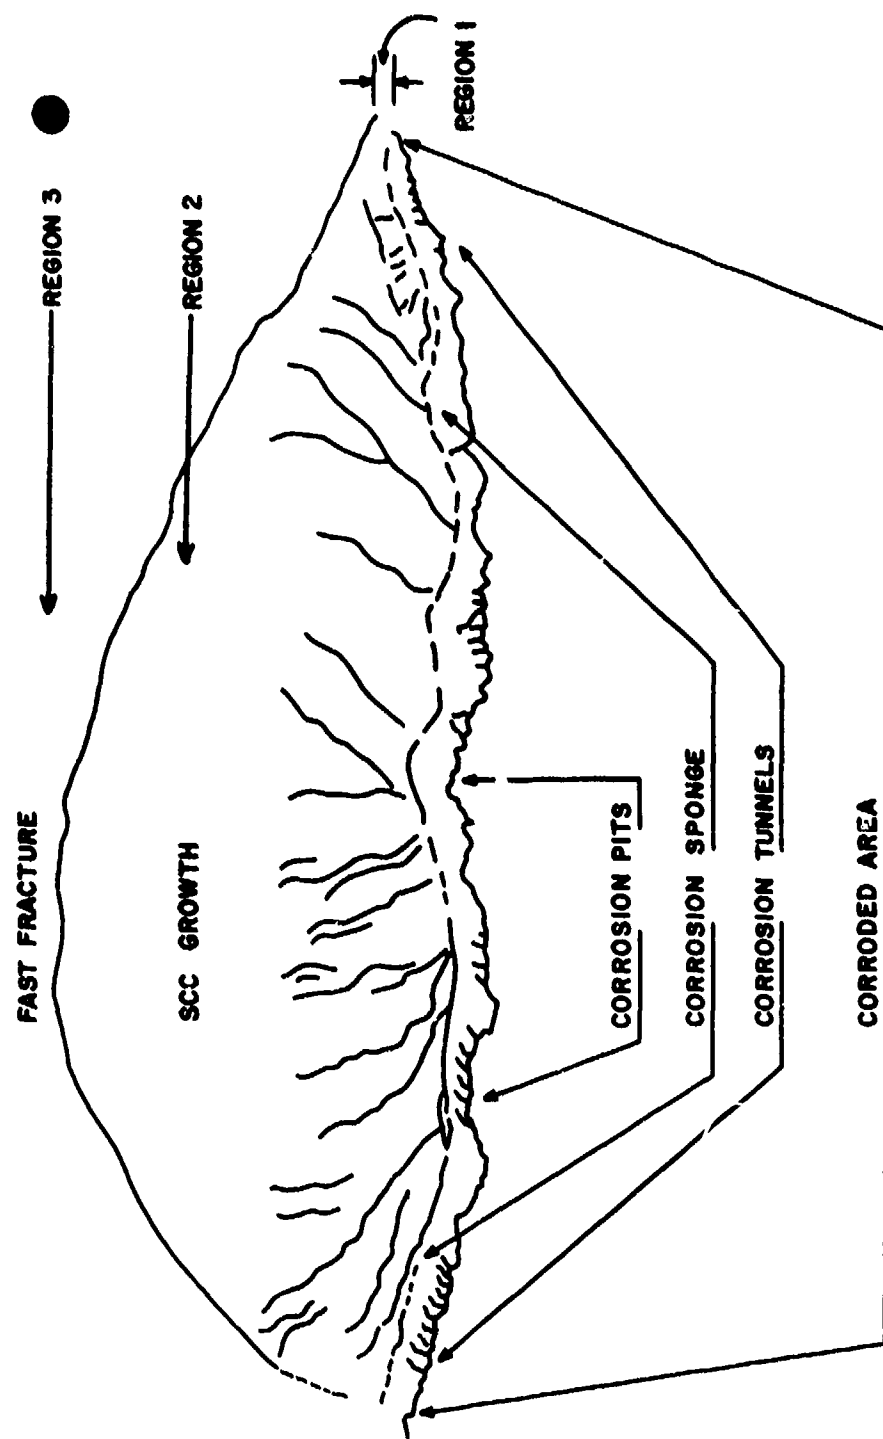
Figure A14. The fracture surface of spring No. 21 showing three regions. Microcracks formed in Region 1 grow by stress corrosion to Region 2 and reach a critical depth for catastrophic failure in Region 3.

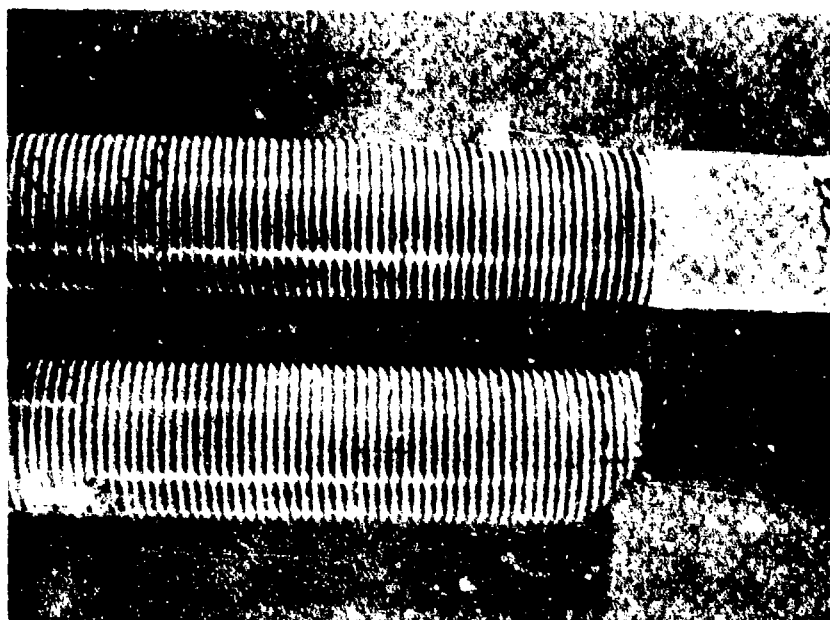
Figure A24. Radial and circumferential flaws revealed by dye-penetrant inspection.

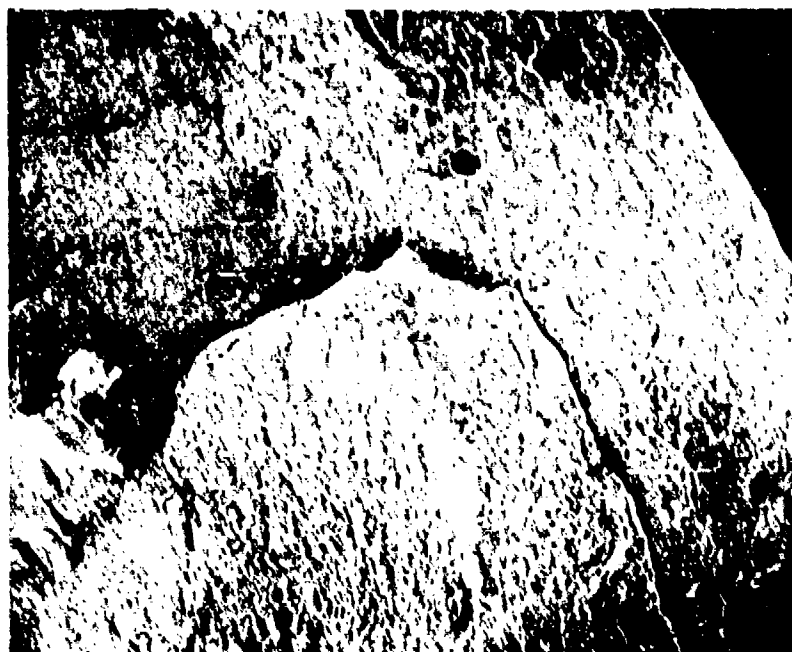
Figure A25. Circumferential crack on outside edge of bolt (10x magnification).

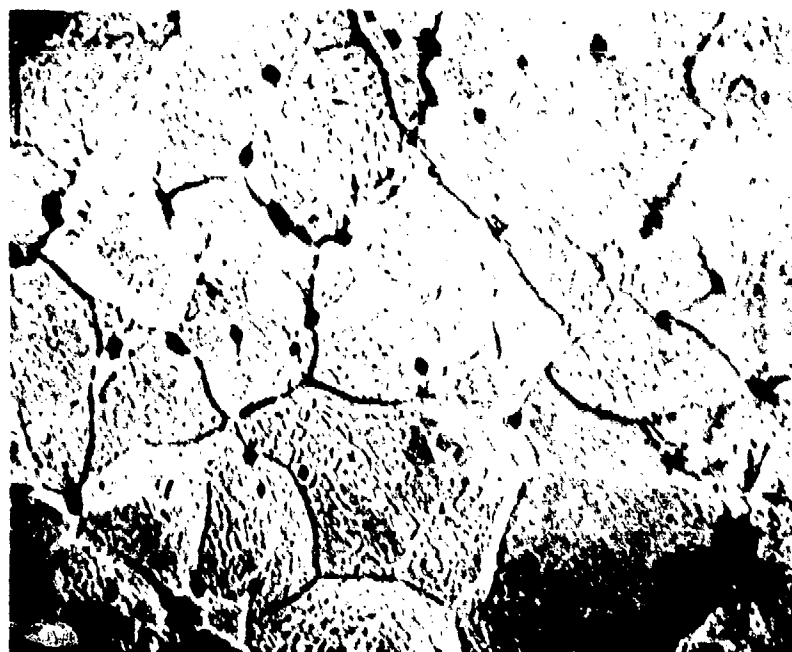
Figure A26. Intergranular cracks resulting from a grain-boundary separation failure mode (1100x magnification).

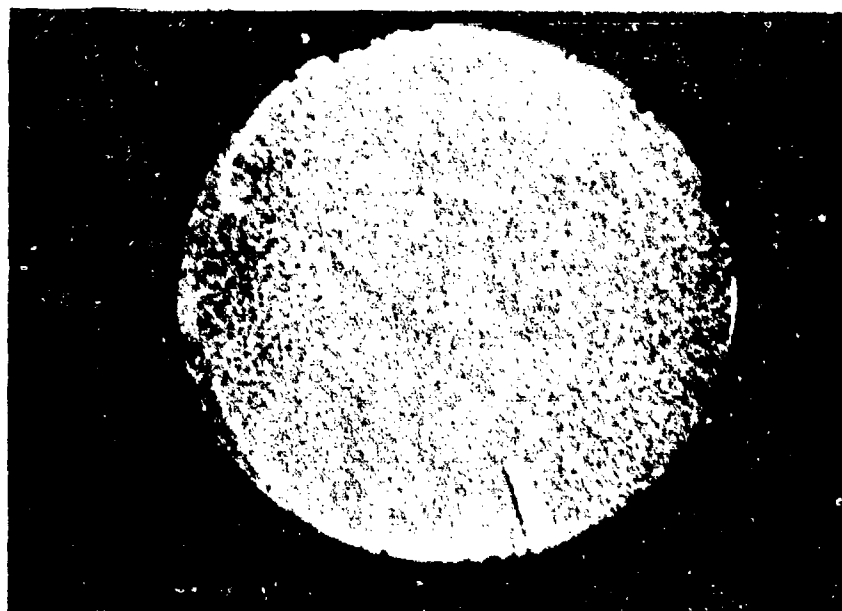
Figure A28. Radial cracks in bolt revealed by dye-penetrant inspection (1.45x magnification).

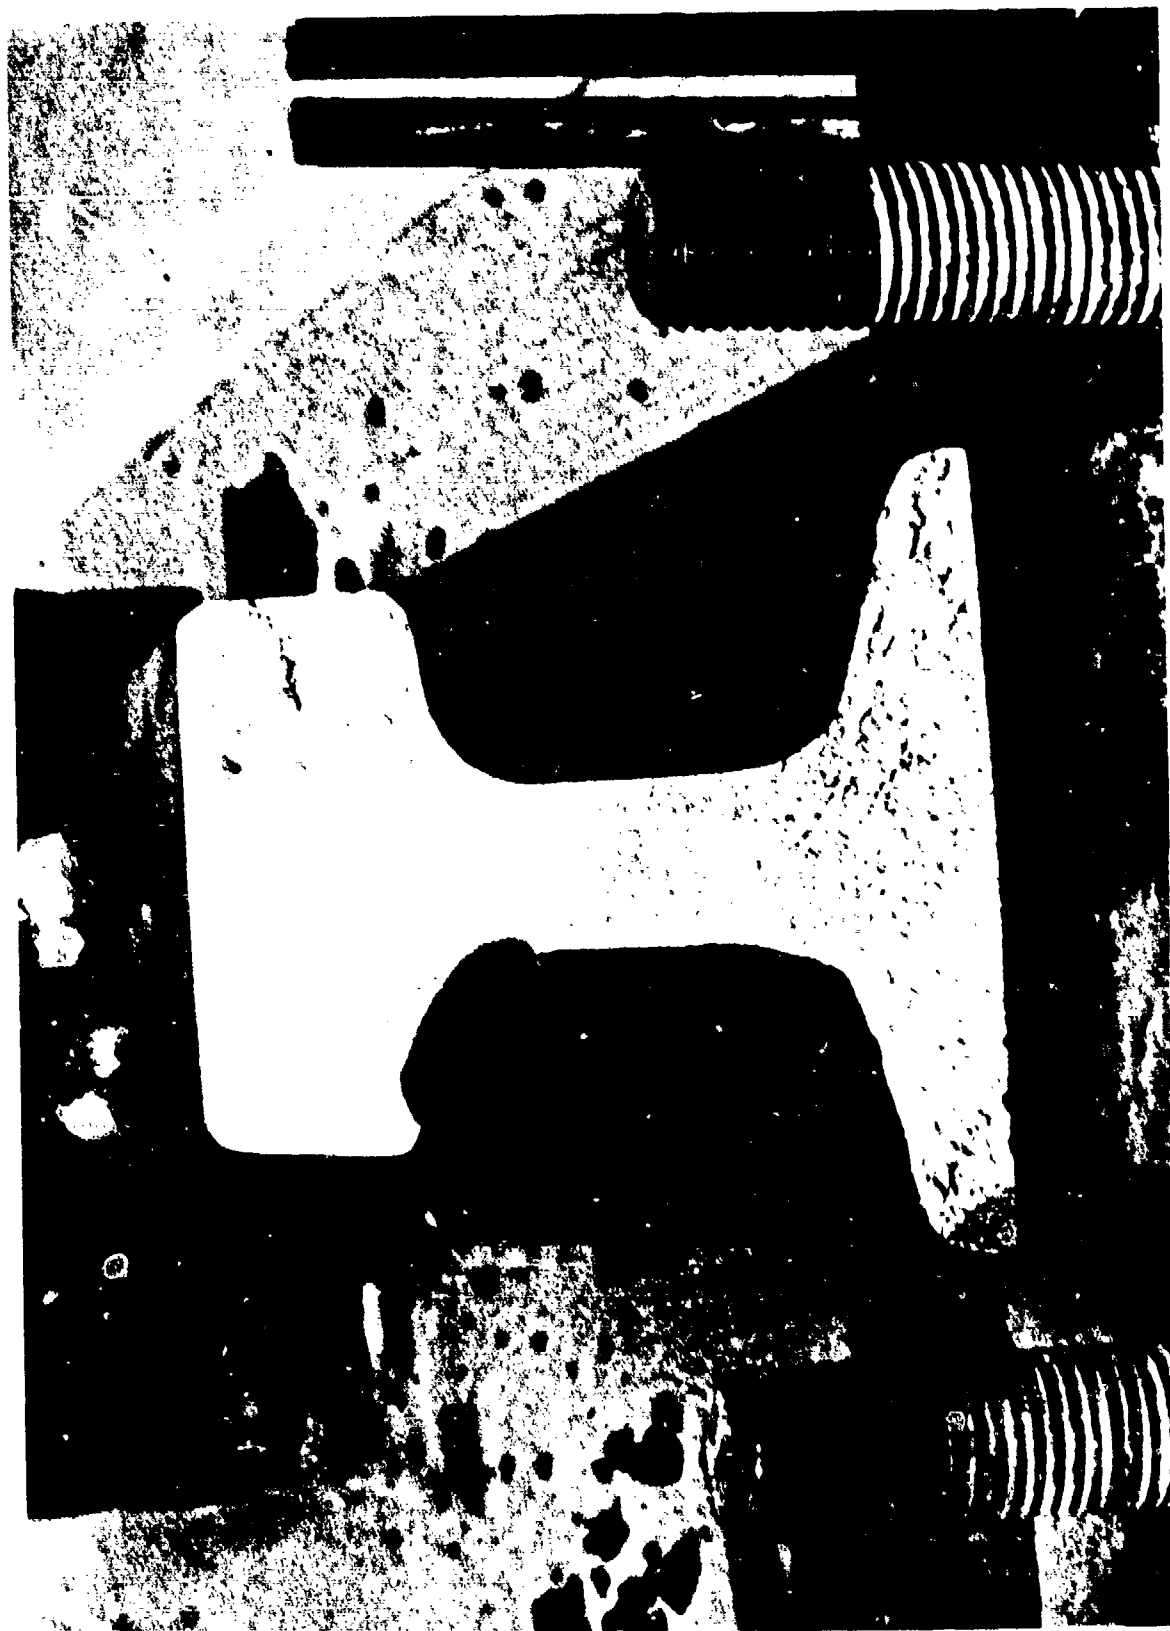
Figure A34. Cross section of the fractured west rail.
